PROJECT NUMBER: PNB037-0708

JUNE 2009

Eight year final inspection of model windows exposed in the accelerated field simulator

L. Cookson and J. Carr

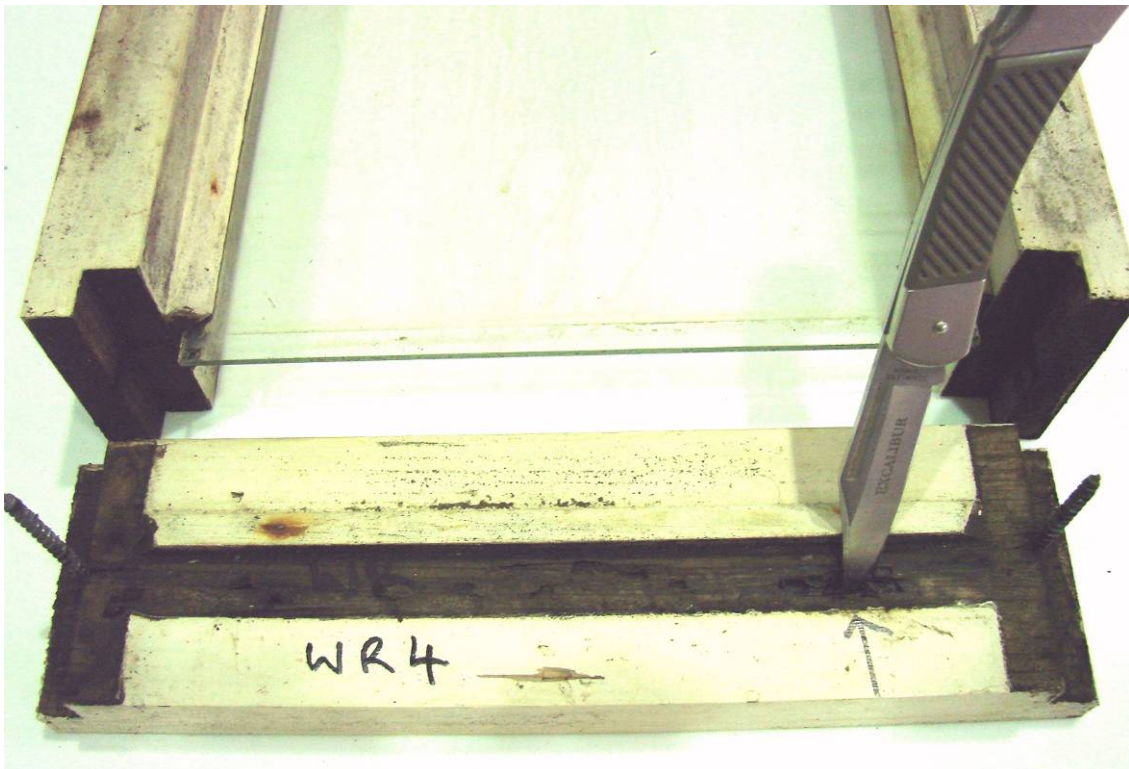
Figure 4. Bottom sill of untreated painted *T. plicata* window WR4 with 12 mm deep brown rot under glass + beading after eight years' exposure.

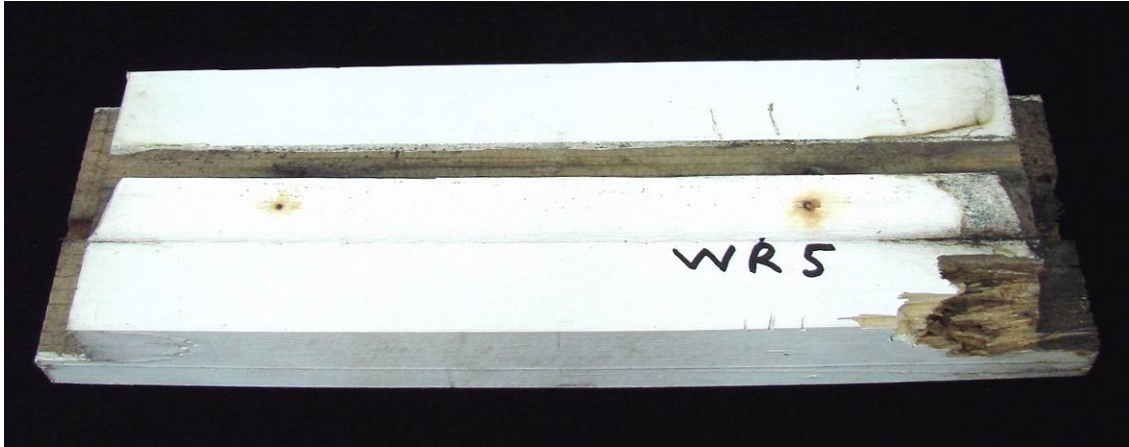
Figure 5. Bottom sill of untreated painted *T. plicata* window WR5 with 35+ mm deep brown rot from right end after eight years' exposure.

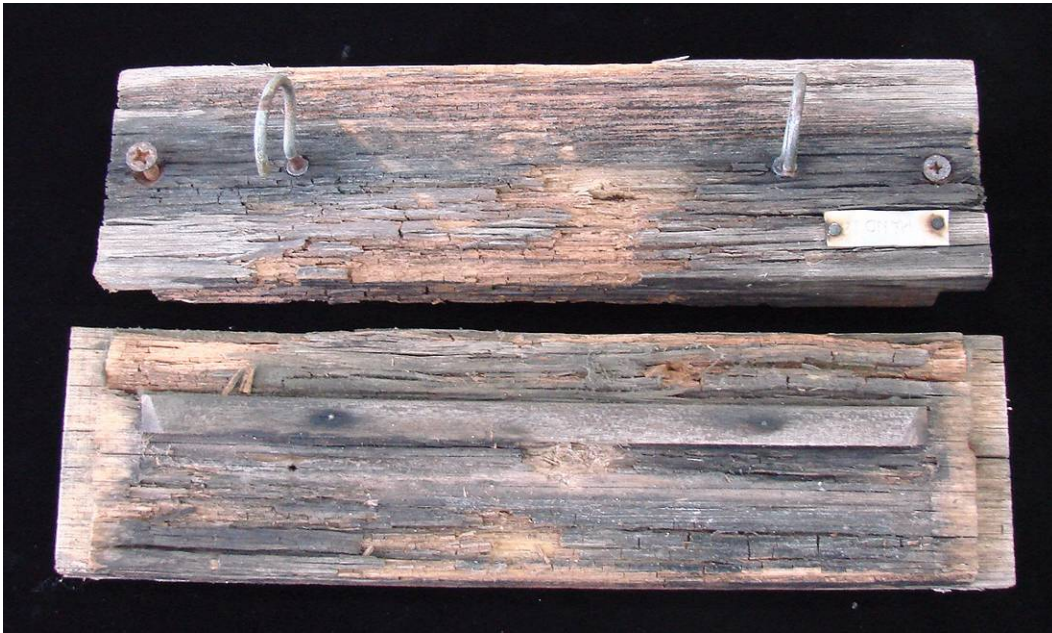
A major contrast in performance was for *E. regnans* treated with azole LOSP using the commercial schedule, and then painted or left unpainted. Painted windows had only light decay (mean rating 7.4) while unpainted windows had moderate to heavy decay (mean rating 4.5, Figure 8). This result clearly illustrates the benefits to LOSP-treated wood of paint protection. Note that retentions for the LOSP-treated timber assigned to the unpainted set of windows were slightly higher than for similar windows that were painted (Appendix 1). In unpainted windows, some decay occurred on the top face of the window (Figure 8), compared to painted windows where decay from this direction was absent.

Figure 8. Unpainted azole LOSP-treated *E. regnans* windows. Top piece shows upper surface of top section of MAND14. Lower piece shows upper surface of bottom sill (one beading retained) of MAND13.

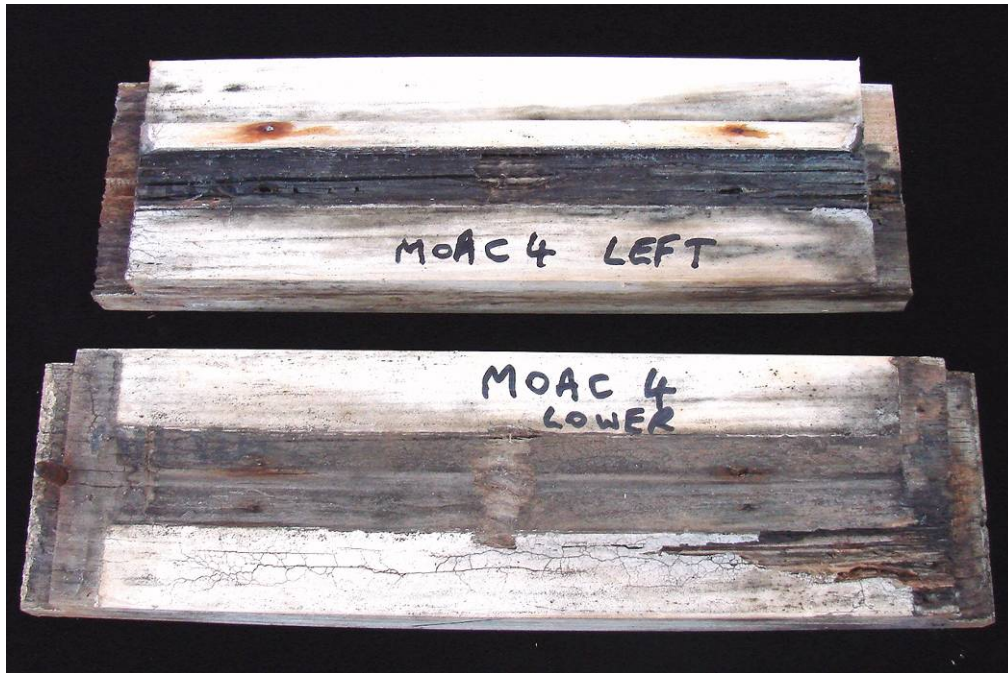
After six years, there was little difference between *E. regnans* painted windows that had been treated with LOSP containing TBTN or azoles. However, the eight year inspection has seen a rapid decline in the performance of TBTN-treated windows (Figures 7 and 9) and the mean rating was 4.5 compared to 7.4 for azoles. This result appears due to the premature degradation of TBTN, as discussed in a recent review¹³.

Figure 9. TBTN LOSP-treated *E. regnans* window MOAC4, painted. Lower piece shows upper face of bottom sill with 35+ mm brown rot in the left end (reversed in photo) that was dipped after machining. Top piece shows inside face of left piece with 2 mm decay under beading (it also has 35+ mm decay at either end).

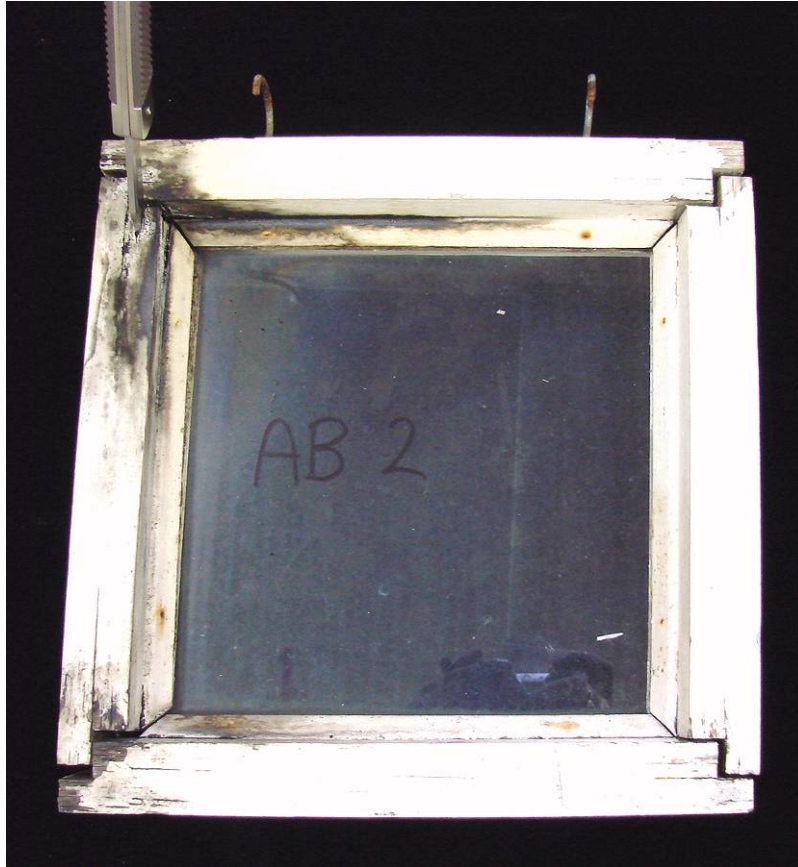
When the ends cut after VPI boron-treatment were resealed by dipping in boron solution, there were nine examples of end grain decay (Figure 11). In comparison, all of the azole LOSP-treated eucalypts (commercial schedule) where ends were cut after treatment but resealed by a three minute dip of the ends in azole were sound. This result suggests that treated seasoned timber (whether treated with boron or LOSP) are better resealed with LOSP rather than boron.

Figure 11. Painted VPI boron-treated *E. delegatensis* window AAB2, with 35+ mm brown rot in both ends of upper left joint (machined seasoned wood dipped in boron after treatment). Other joints without decay.

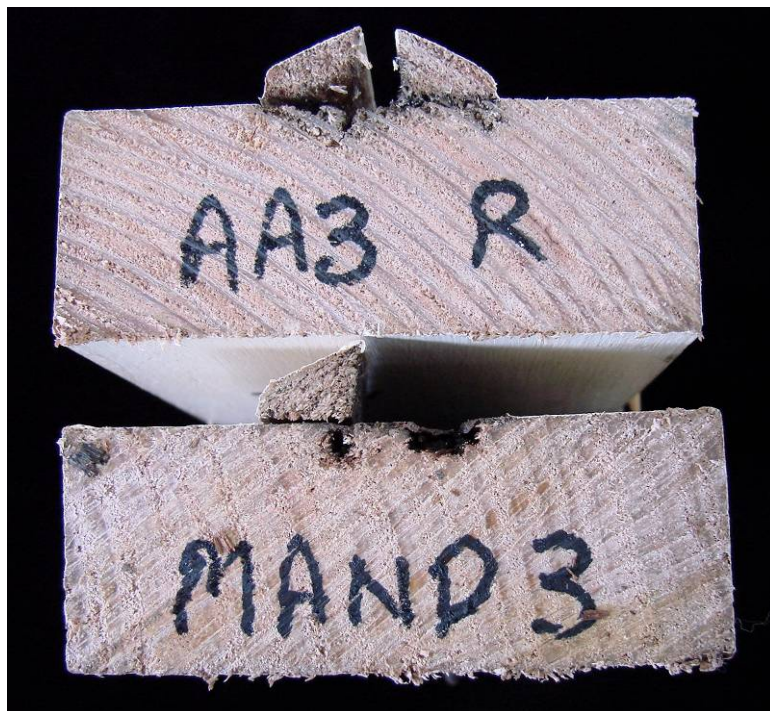
Figure 17. Centre of timber sections cut for inspection, showing 5-6 mm decay and staining under glass edge (removed) and quad beading.

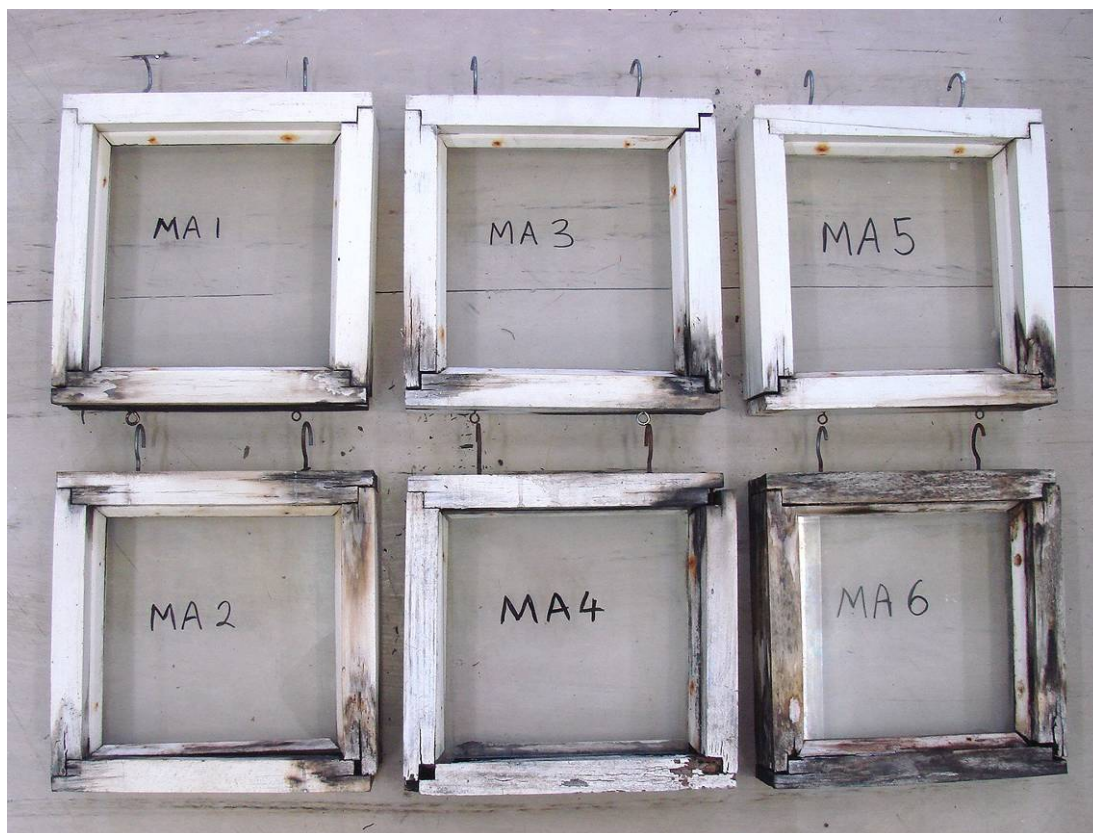
Untreated *E. regnans* = Mountain ash (MA) – Painted white

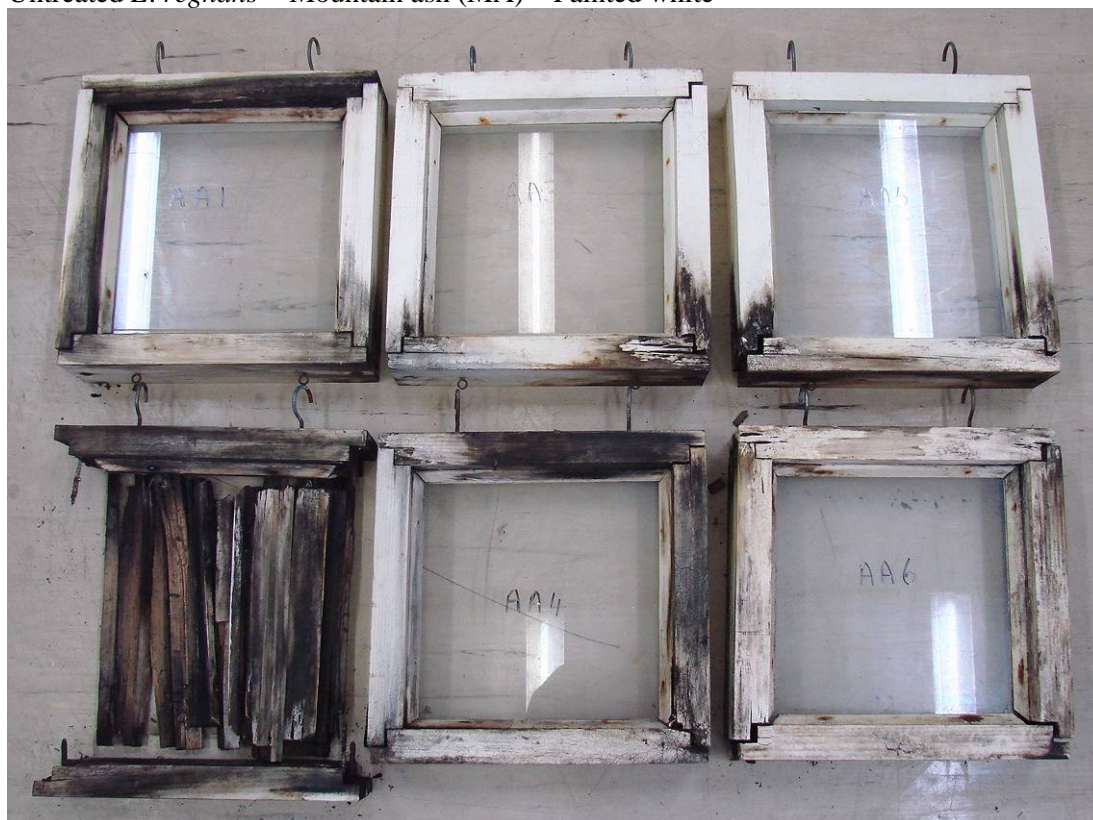
Untreated *E. delegatensis* = Alpine ash (AA) – Painted white

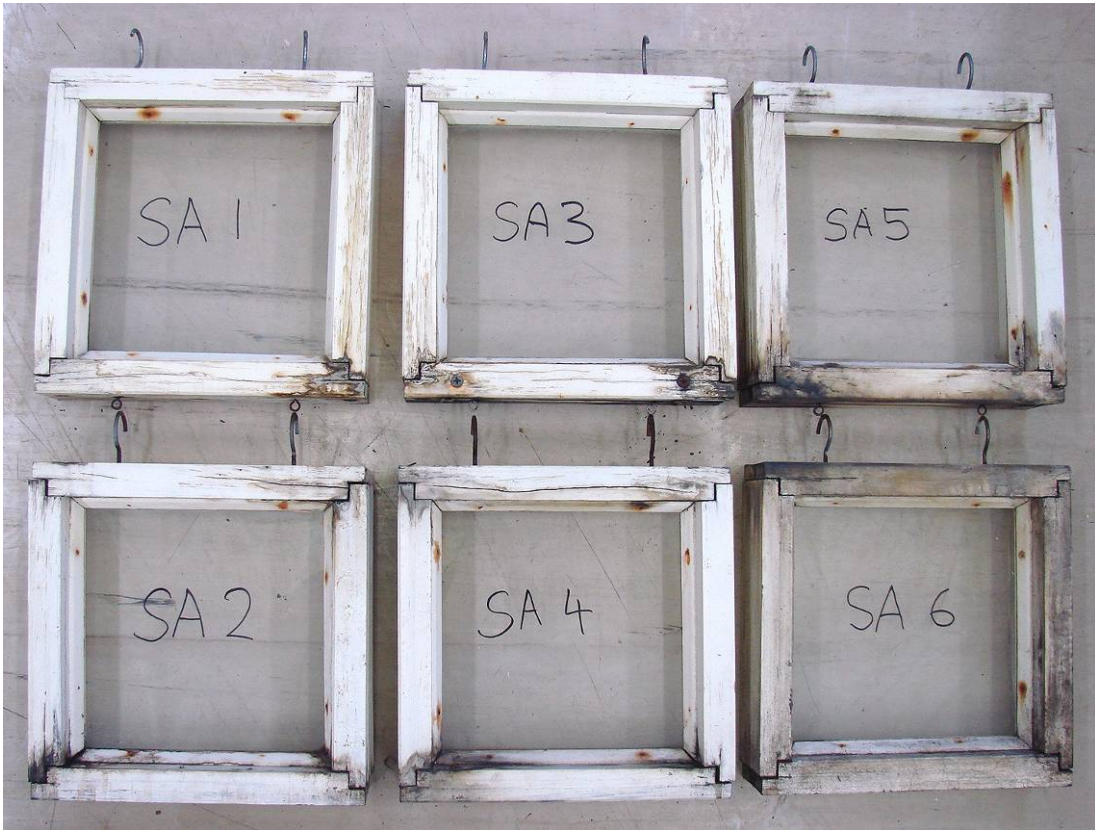
Untreated *E. sieberi* = Silvertop ash (SA) – Painted white

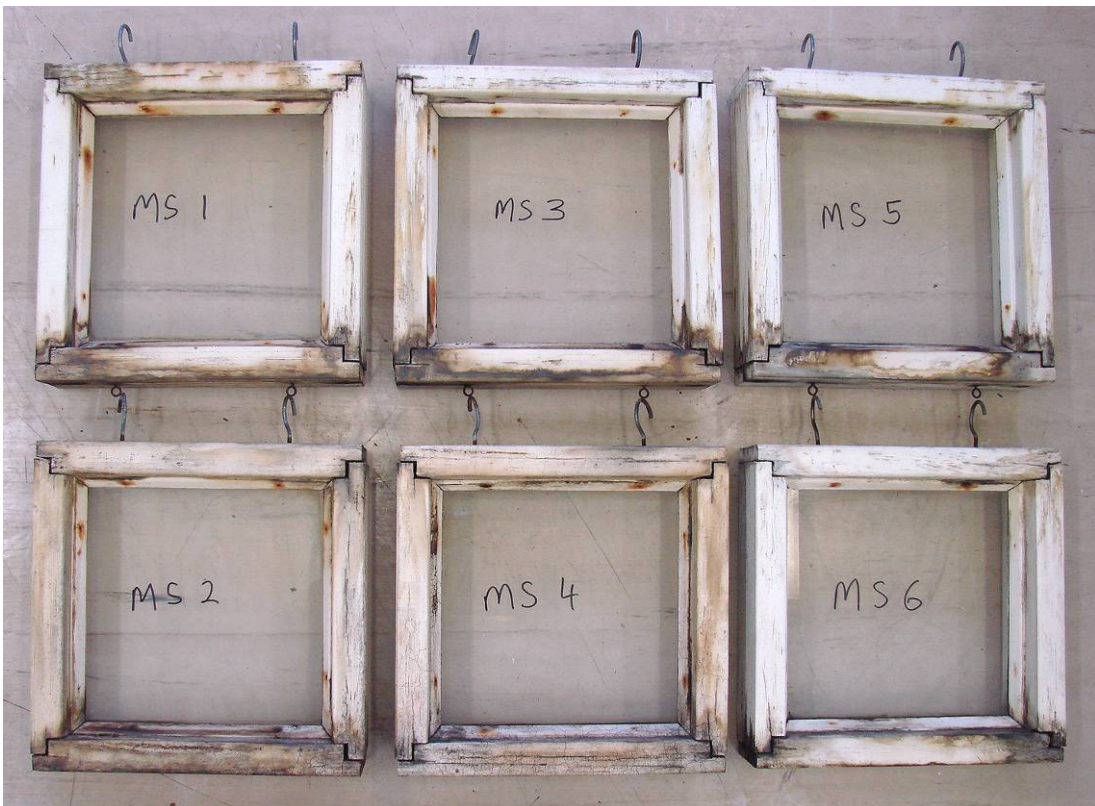
Untreated *E. obliqua* = messmate stringybark (MS) – Painted white

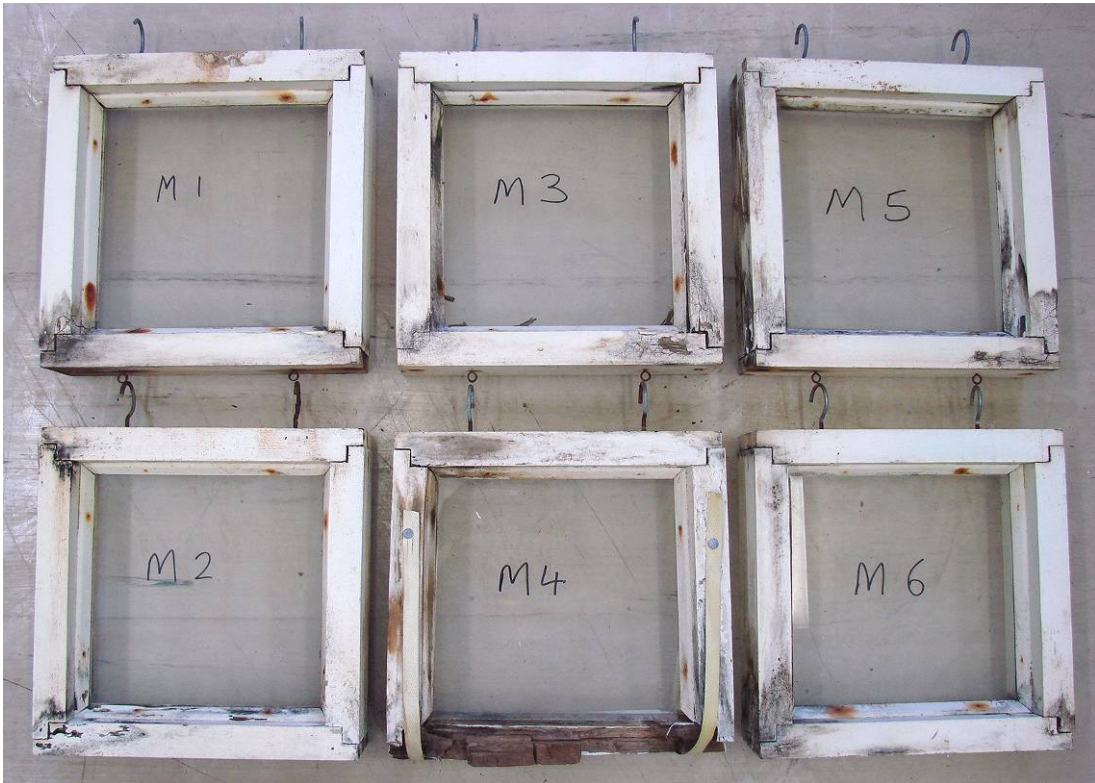
Untreated *Shorea* sp. = meranti (M) – Painted white

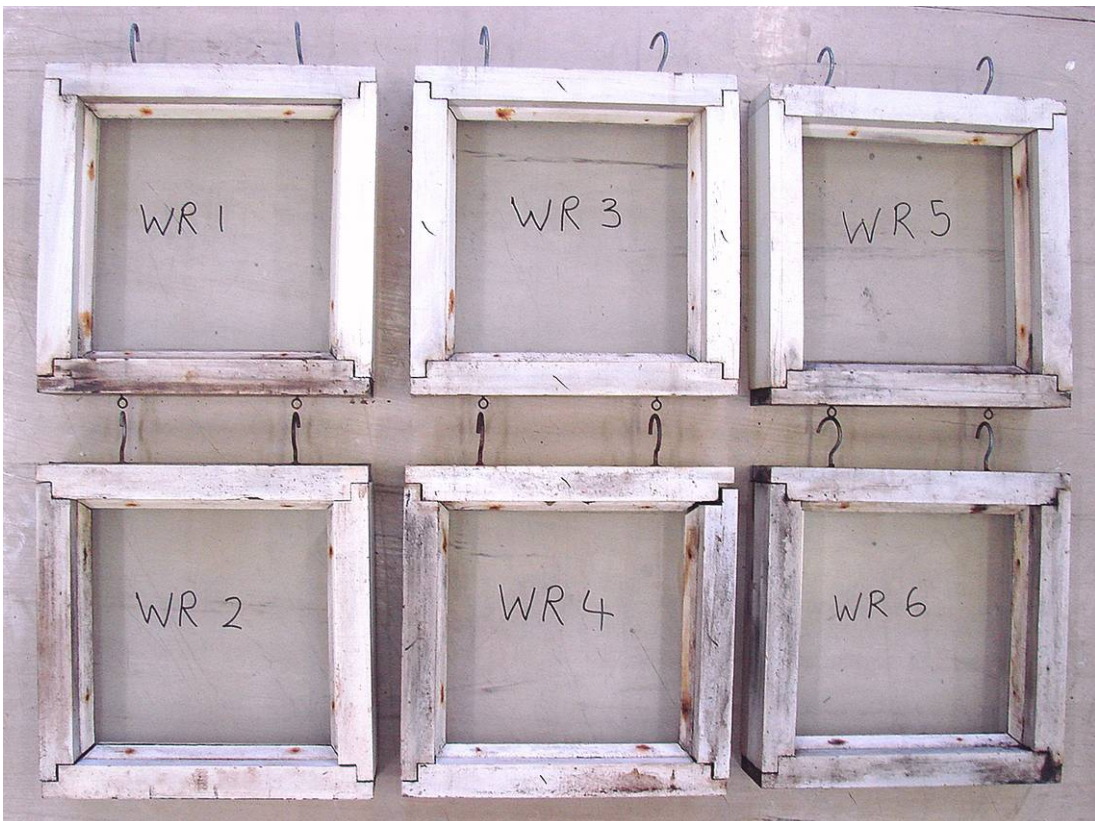
Untreated *T. plicata* = western red cedar (WR) – Painted white

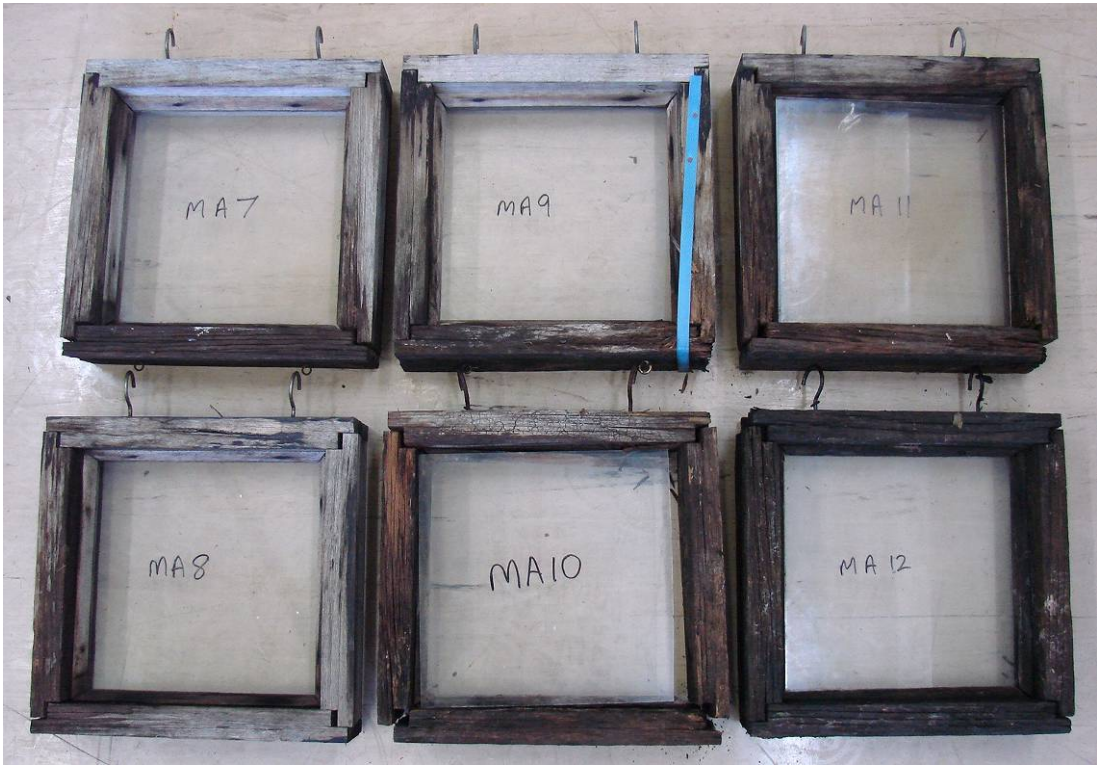
Untreated *E. regnans* = Mountain ash (MA) – Unpainted

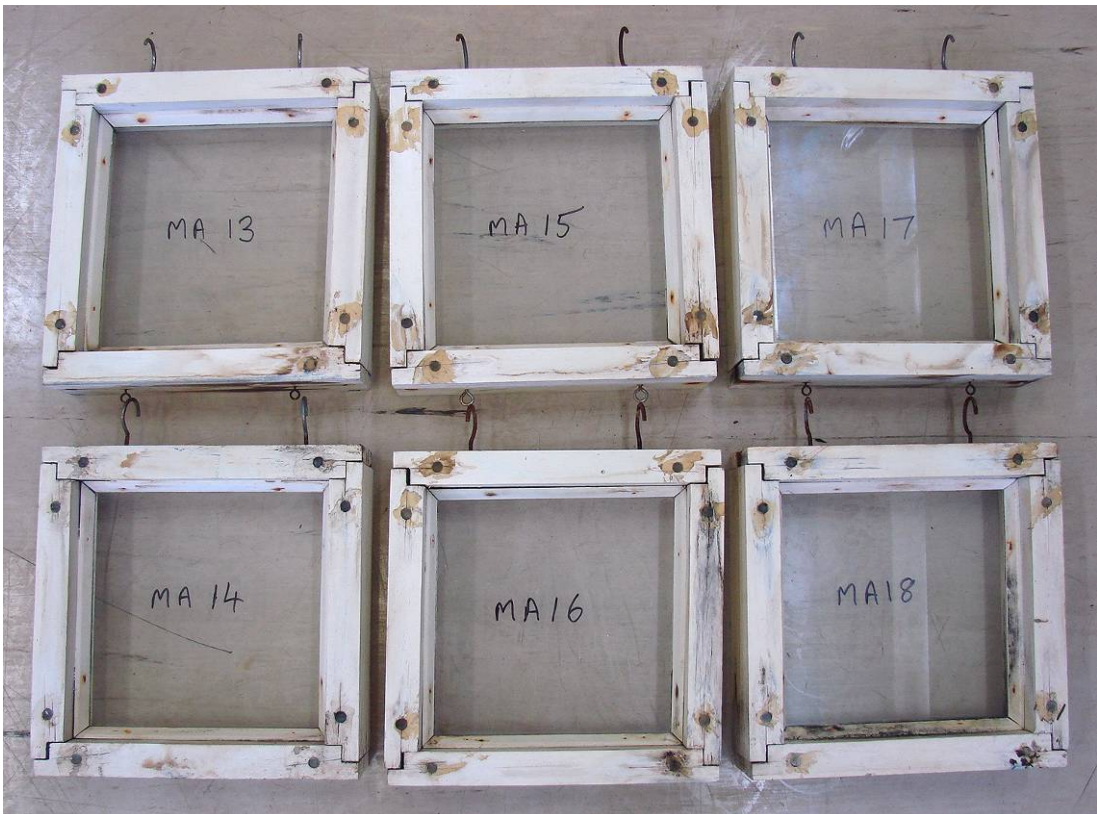
Untreated *E. regnans* = Mountain ash (MA) – but with No-rot rods, painted white. Note drill holes with rods near corners sealed with silicone.

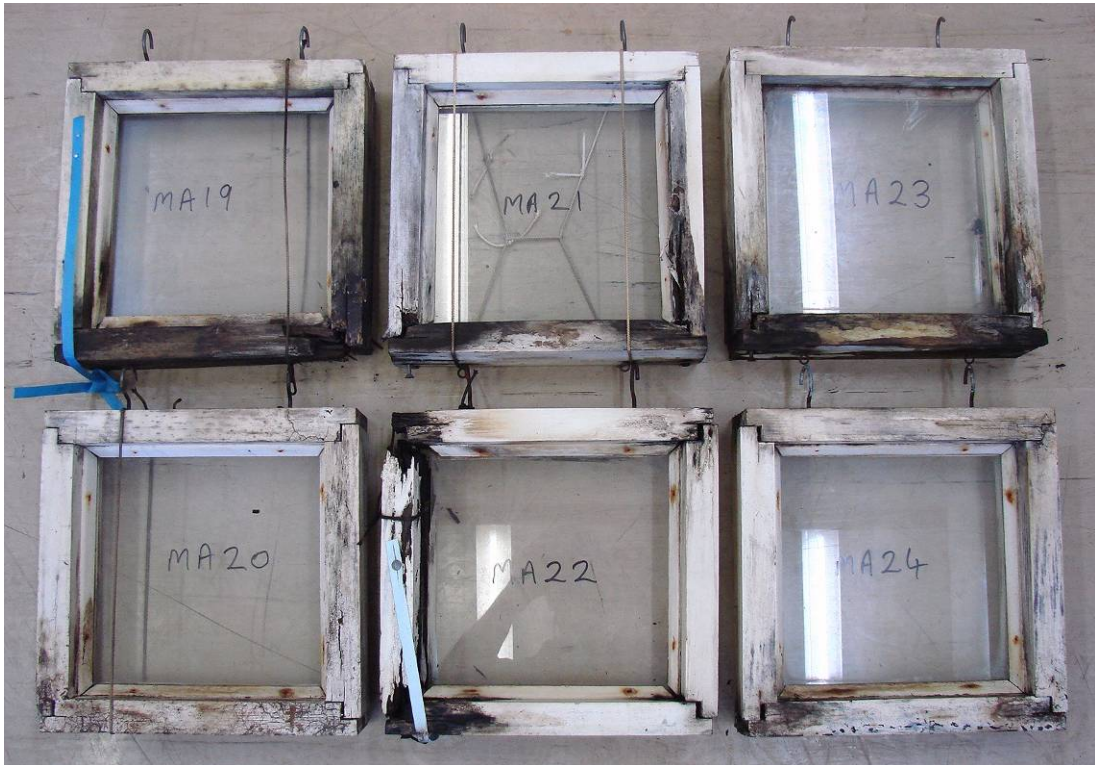
Untreated *E. regnans* = Mountain ash (MA) – Endgrain in rebate sealed, painted white.

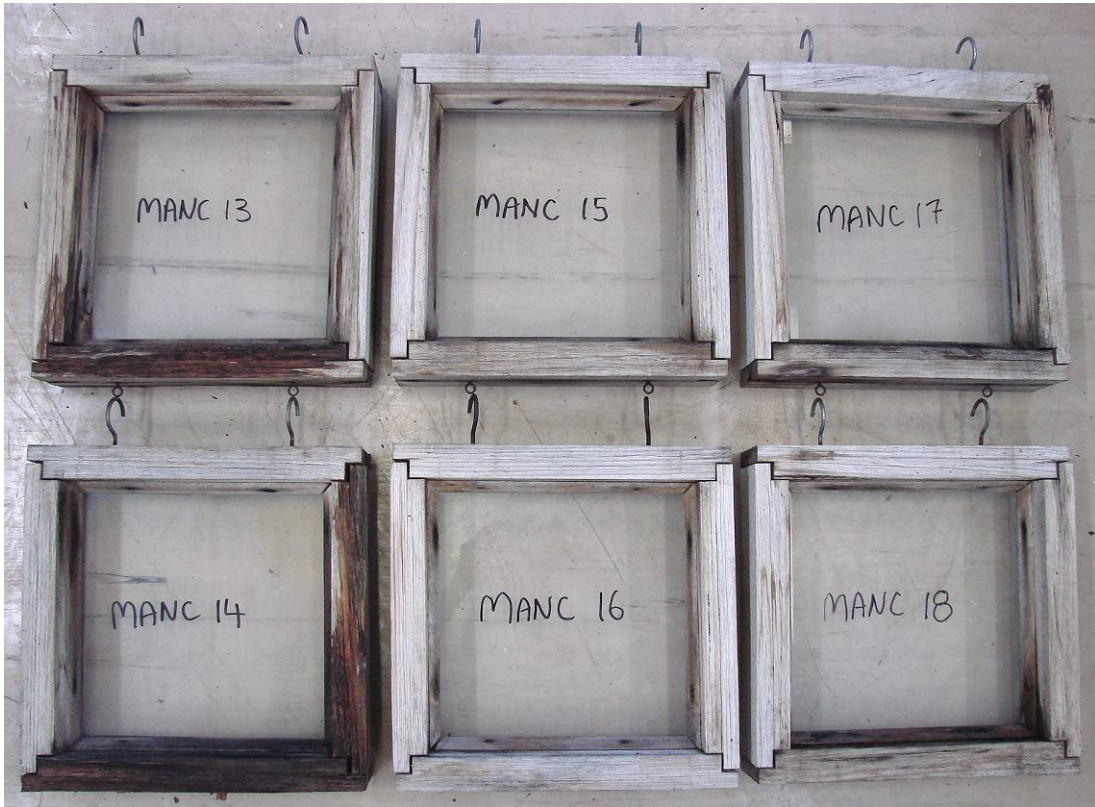
E. regnans = Mountain ash (MANC) – azole LOSP using a commercial schedule, unpainted.

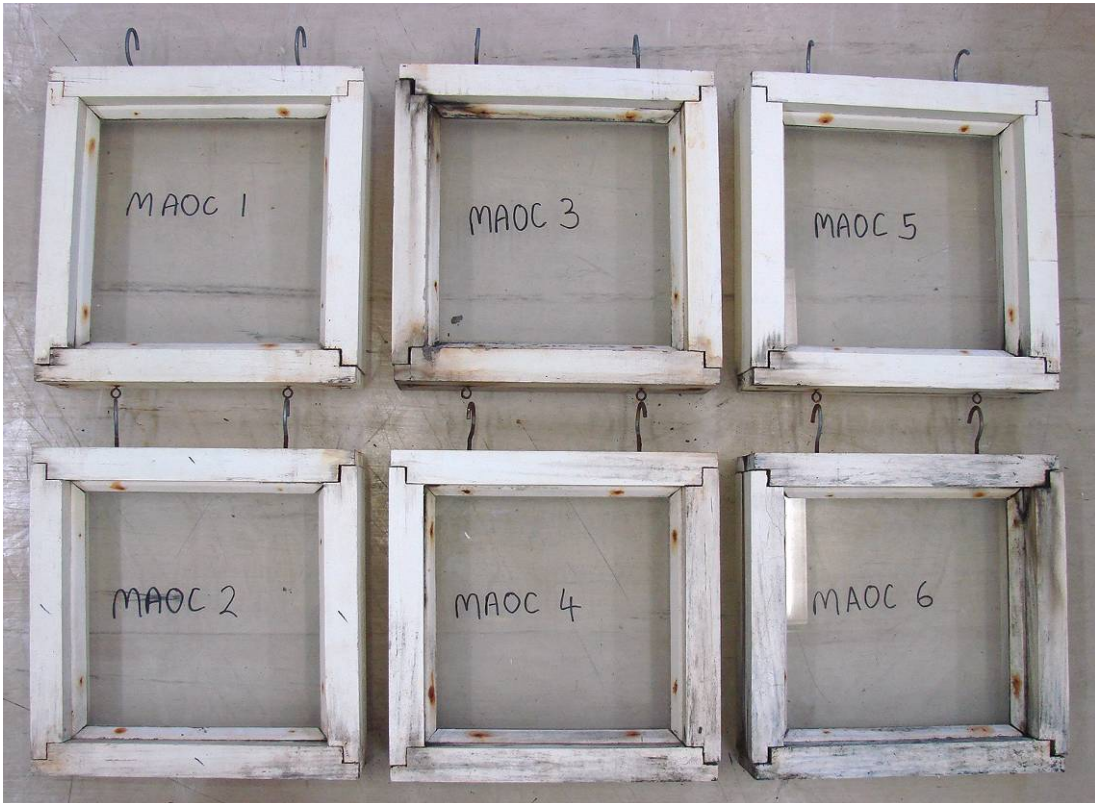
E. regnans = Mountain ash (MAOC) – TBTN LOSP using commercial schedule, painted white.
